COMMERCIAL WINDSTORM MITIGATION REPORT (OIR-B1-1802)

Meridian on Sand Key

1200 Gulf Blvd, Units 101-102, 105, 201-1706, 1801-1805, 1901,1903-1905, 2001, 2003, 2005, 2101,
2103, 2105

As of 11/20/2020
FPAT File# MIT2015265

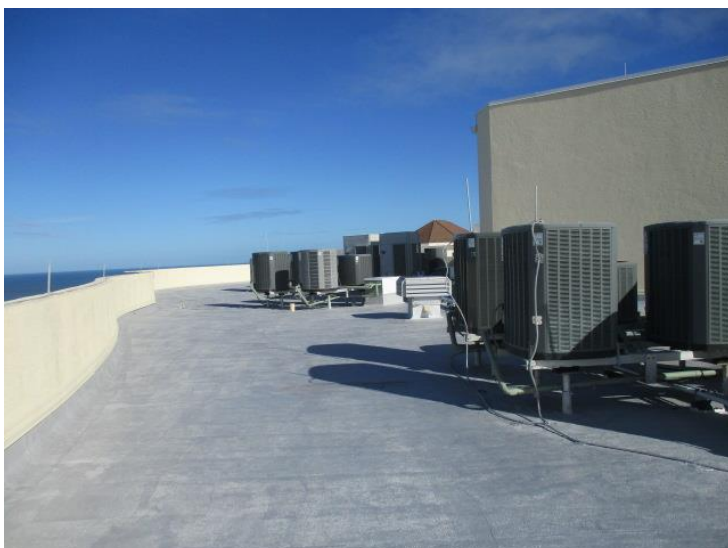
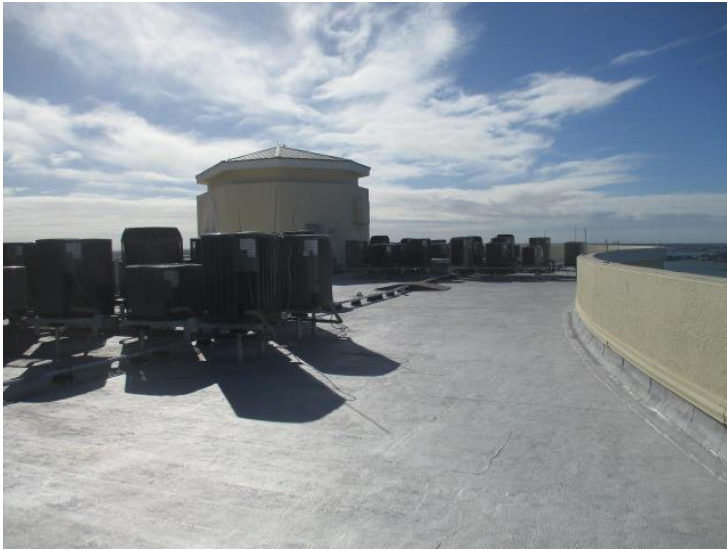
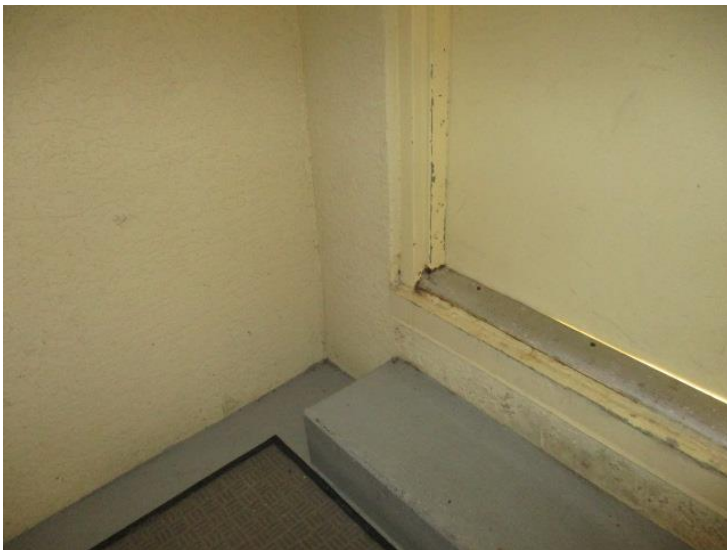
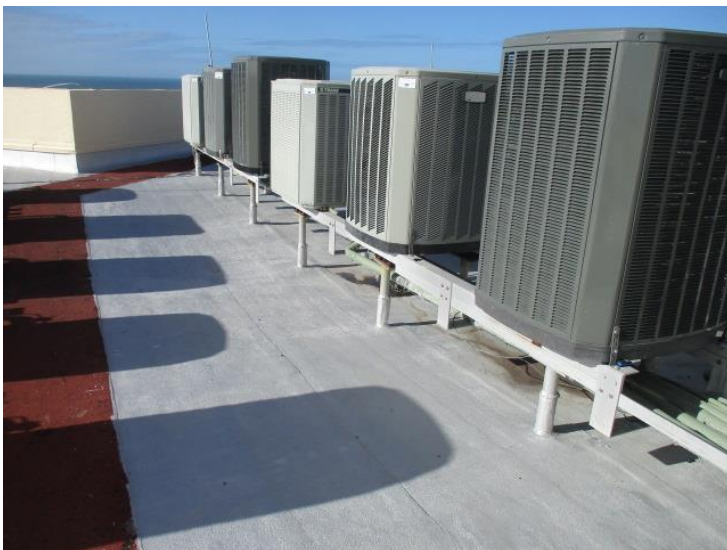
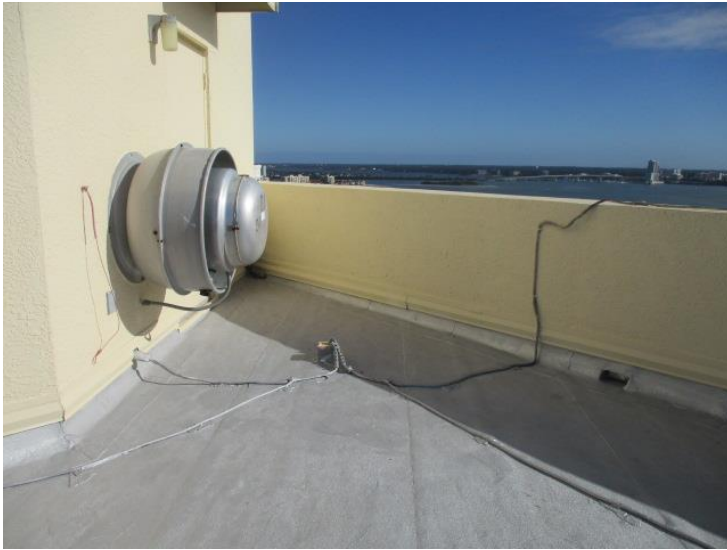
Roof Construction

- 3. Roof Deck Attachment:** **Reinforced Concrete Roof Deck**
Comments: Inspection verified a roof structure composed of cast-in-place or pre-cast structural concrete designed to be self-supporting and integrally attached to the wall / support system.

- 4. Roof to Wall Attachment:** **Structural**
Comments: Inspection verified a roof structure composed of cast-in-place or pre-cast structural concrete designed to be self-supporting and integrally attached to the wall / support system.

- 5. Roof Geometry:** **Flat Roof**
Comments: Inspection verified flat roof shape, refer to attached photographs.
- 6. SWR:** **No**
Comments: SWR does not apply to reinforced concrete roof decks.
